**Flood Control Project Maintenance
Levee Inspections**
LMA District Cover Sheet
Spring 2019 Levee Inspection Results

Madera County FCWCA

Spring 2019 Levee Inspection Results

Waterway			Bank	Unit Miles
Unit No. 01 Ash Slough			Right	2.37
	Spring (March - May)	Summer (June - August)	(September - November) Fall	Winter (December - February)
Unit Maintenance Rating (Fall Only)				
Date of Inspection	5/9/2019 - 5/9/2019			
DWR Inspector	Corey Fujitani			
Accompanied By	Dario Dominguez Madera County

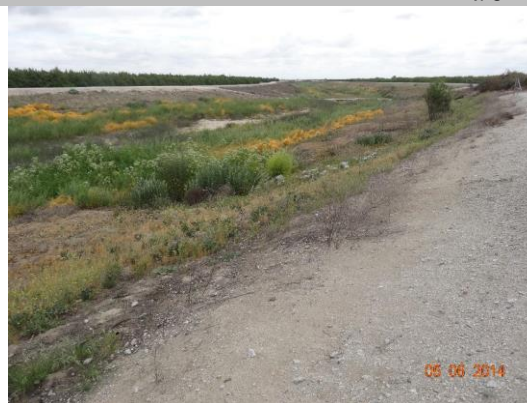
Photo 1 of 3 : UCIP_SP_2019_52864_64596.jpg

LM Start	8.53	Rating **	M	Issue No.	90
LM End	8.53	Issue Type +	En	Location *	
Category	Supplemental			GPS Latitude/Longitude	
				Start	End
Item	DWR UCIP Field Study			36.971462 °	36.971462 °
				-120.220276 °	-120.220276 °
DWR ID	21534				
Comment Code					
Inspector Comment					
FS_ID:52864 DS_ID:21534 EP_NO: N/A Repair Type: Non-Urgent Crossing Status: Found UCIP Comments: 05/06/2014 Need to contact owner. Rip rap has been added around concrete headwall on waterward side--need to determine details for rip rap around structure. (DWR UCIP - O. Magana) FIELD_STRUCT_DESC: 30-inch corrugated metal gravity drainage pipe through the levee, 11 feet below the crown. Headwall and wing wall on each end. Flap gate on the waterside (WS) end. [Additional Reference(s): DWR Levee Log, 2005]. FS Date: 5/6/2014

View of waterward side.

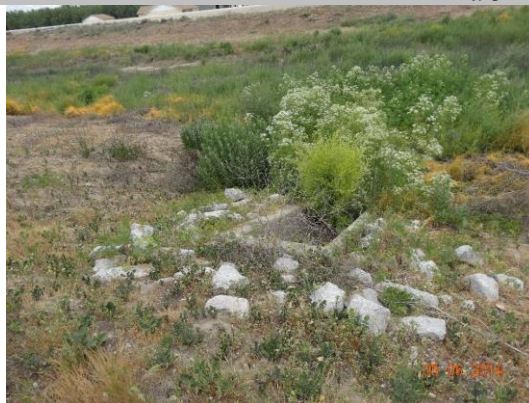
Photo 2 of 3 : UCIP_SP_2019_52864_64599.jpg

LM Start	8.53	Rating **	M	Issue No.	90 (cont)	
LM End	8.53	Issue Type +	En	Location *		
Category	Supplemental			GPS Latitude/Longitude		
				Start		End
Item	DWR UCIP Field Study			36.971462 °		36.971462 °
				-120.220276 °		-120.220276 °
DWR ID	21534					
Comment Code						
Inspector Comment						
FS_ID:52864 DS_ID:21534 EP_NO: N/A Repair Type: Non-Urgent Crossing Status: Found UCIP Comments: 05/06/2014 Need to contact owner. Rip rap has been added around concrete headwall on waterward side--need to determine details for rip rap around structure. (DWR UCIP - O. Magana) FIELD_STRUCT_DESC: 30-inch corrugated metal gravity drainage pipe through the levee, 11 feet below the crown. Headwall and wing wall on each end. Flap gate on the waterside (WS) end. [Additional Reference(s): DWR Levee Log, 2005]. FS Date: 5/6/2014

Rip rap around concrete headwall located on waterward side.

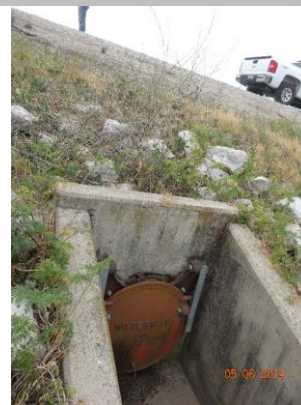
Photo 3 of 3 : UCIP_SP_2019_52864_64598.jpg

LM Start	8.53	Rating **	M	Issue No.	90 (cont)
LM End	8.53	Issue Type +	En	Location *

Flap gate visible on waterward side.

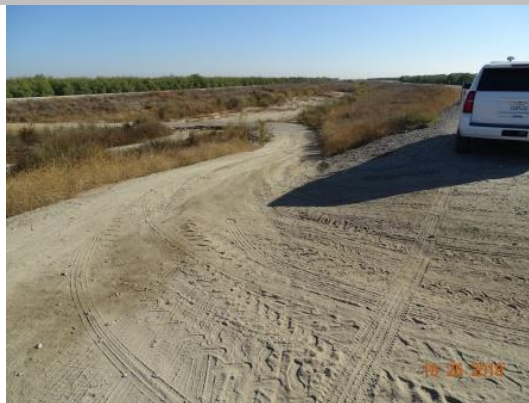
Photo 1 of 1 : SP_2019_NA0011_147_55_20190307_00031.jpg

LM Start	8.59	Rating **	M	Issue No.	55
LM End	8.59	Issue Type +	En	Location *	WS
Category	Earthen Levee			GPS Latitude/Longitude	
				Start	End
Item	Encroachments			36.971314 °	36.971314 °
				-120.219339 °	-120.219339 °
DWR ID	DWR_NA0011_06_f_2018_55				
Comment Code					
RA : Ramp					
Inspector Comment

unpermitted ramp on waterside slope. (Fall 2018)

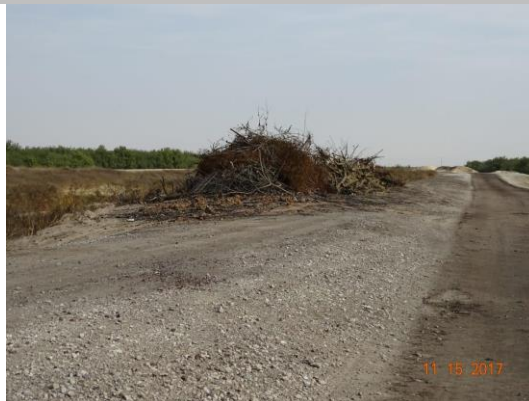
Photo 2 of 2 : SP_2019_NA0011_147_50_20190307_00025.jpg

LM Start	8.93	Rating **	U	Issue No.	50
LM End	8.93	Issue Type +	En	Location *	CR
Category	Earthen Levee			GPS Latitude/Longitude	
				Start	End
Item	Encroachments			36.972286 °	36.972286 °
				-120.213284 °	-120.213284 °
DWR ID	DWR_NA0011_06_f_2017_50				
Comment Code					
PR : Prunings					
Inspector Comment					
Remove or burn prunings pile on crown.

LM Start	8.93	Rating **	U	Issue No.	50 (cont)
LM End	8.93	Issue Type +	En	Location *	CR

Prunings pile should be removed from levee crown, slope and toe to allow inspection and access.

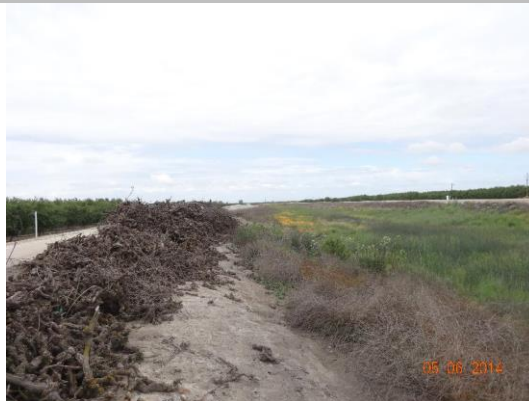
Photo 1 of 3 : UCIP_SP_2019_53156_64605.jpg

Comment Code						
Inspector Comment						
FS_ID:53156 DS_ID:21530 EP_NO: N/A Repair Type: Urgent Crossing Status: Found UCIP Comments: 10/31/2018 Same as last inspection. Surface erosion present due to highly erodible soil. Deep hole behind concrete headwall presently unable to confirm if hole is associated with burrow activity or sink hole. Recommend internal inspection to determine pipe integrity through the levee. Crossing remains Urgent due to the unknown condition of the pipe integrity through the levee. (O. Magana - DWR UCIP) 07/14/2016 Surface erosion still present on LS shoulder. Unable to determine if surface erosion is due to internal pipe failure. Unable to locate concrete headwall on WS toe. Need to coordinate with owner to address erosion or potential pipe failure. Also recommend removing dense vegetation on WS. (DWR UCIP - omagana) 05/06/2014 Need to contact owner. Surface erosion on landward slope unable to determine if pipe failed or if rodent activity burrow hole has caused collapse on slope. Need to determine cause for erosion. (DWR UCIP - omagana) FIELD_STRUCT_DESC: 30-inch corrugated metal gravity drainage pipe through the levee, 10.2 feet below the crown. Headwall and wing wall on each end. Flap gate on the waterside (WS) end. [Additional Reference(s): DWR Levee Log, 2005]. FS Date: 10/31/2018 10:21:00 AM

LM Start	8.94	Rating **	U	Issue No.	91 (cont)
LM End	8.94	Issue Type +	En	Location *

View of WS.

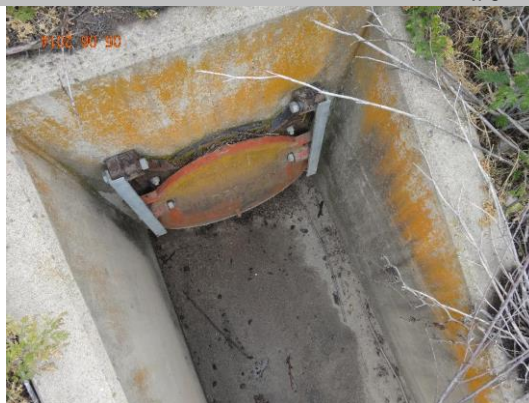
Photo 2 of 3 : UCIP_SP_2019_53156_64604.jpg

Flap gate visible on WS.

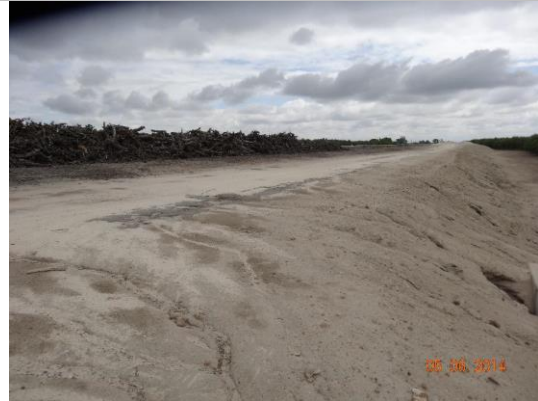
Photo 3 of 3 : UCIP_SP_2019_53156_64603.jpg

Comment Code						
Inspector Comment						
FS_ID:53156						
DS_ID:21530						
EP_NO: N/A						
Repair Type: Urgent						
Crossing Status: Found						
UCIP Comments: 10/31/2018 Same as last inspection. Surface erosion present due to highly erodible soil. Deep hole behind concrete headwall presently unable to confirm if hole is associated with burrow activity or sink hole. Recommend internal inspection to determine pipe integrity through the levee. Crossing remains Urgent due to the unknown condition of the pipe integrity through the levee. (O. Magana - DWR UCIP)						
07/14/2016 Surface erosion still present on LS shoulder. Unable to determine if surface erosion is due to internal pipe failure. Unable to locate concrete headwall on WS toe. Need to coordinate with owner to address erosion or potential pipe failure. Also recommend removing dense vegetation on WS. (DWR UCIP - omagana)						
05/06/2014 Need to contact owner. Surface erosion on landward slope unable to determine if pipe failed or if rodent activity burrow hole has caused collapse on slope. Need to determine cause for erosion. (DWR UCIP - omagana)

FIELD_STRUCT_DESC: 30-inch corrugated metal gravity drainage pipe through the levee, 10.2 feet below the crown. Headwall and wing wall on each end. Flap gate on the waterside (WS) end. [Additional Reference(s): DWR Levee Log, 2005].						
FS Date: 10/31/2018 10:21:00 AM

View of LS.

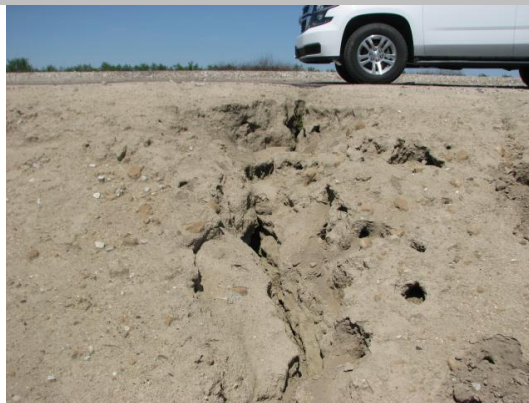
Photo 1 of 1 : SP_2019_NA0011_147_22_20190307_00010.jpg

LM Start	8.99	Rating **	U	Issue No.	22
LM End	8.99	Issue Type +	Ma	Location *	LS
Category	Earthen Levee			GPS Latitude/Longitude	
				Start	End
Item	Erosion / Bank Caving			36.972527 °	36.972527 °
				-120.212225 °	-120.212225 °
DWR ID	DWR_NA0011_06_s_2018_22				
Comment Code					
E2 : Schedule repair of erosion site prior to the next inspection.					
Inspector Comment					
Large finger erosion on landward slope

Looking at finger erosion on landward slope. (Spring 2018)
